Landslides in the White Mountain (Geotechnical Studies and Engineering Tests)

Abstract: *The White Mountain area in the city of Nablus, Palestine, had severe landslides in the year 1997. Necessary studies to find out the causes and to overcome this problem were carried out. This included surveying of the area, geotechnical studies (digging out five boreholes, taking necessary samples, and conducting laboratory tests), and slope stability analysis. The factor of safety was found to be more than one (between 1.4 and 1.8), and this indicated factors other than the natural slope caused the sliding in the White Mountain. It was found that the main causes of landslides were the cuts in the lower part of the area. After the causes for.*

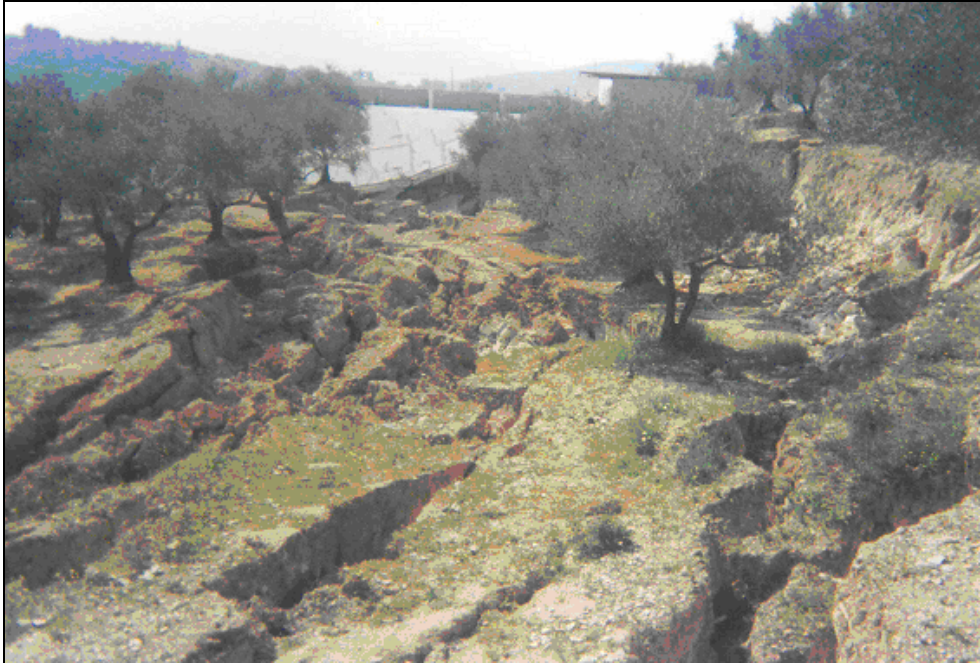
- Landslides in the soil are due to loosing cohesion between the soil strata, since the soil in the area is marl soil (silty clay). This caused large surface cracks and settlements in the soil at the upper part of sliding area as shown in Figure 2, which led to several levels in the soil surface.

Figure (2): Cracks and settlements in the sliding site.

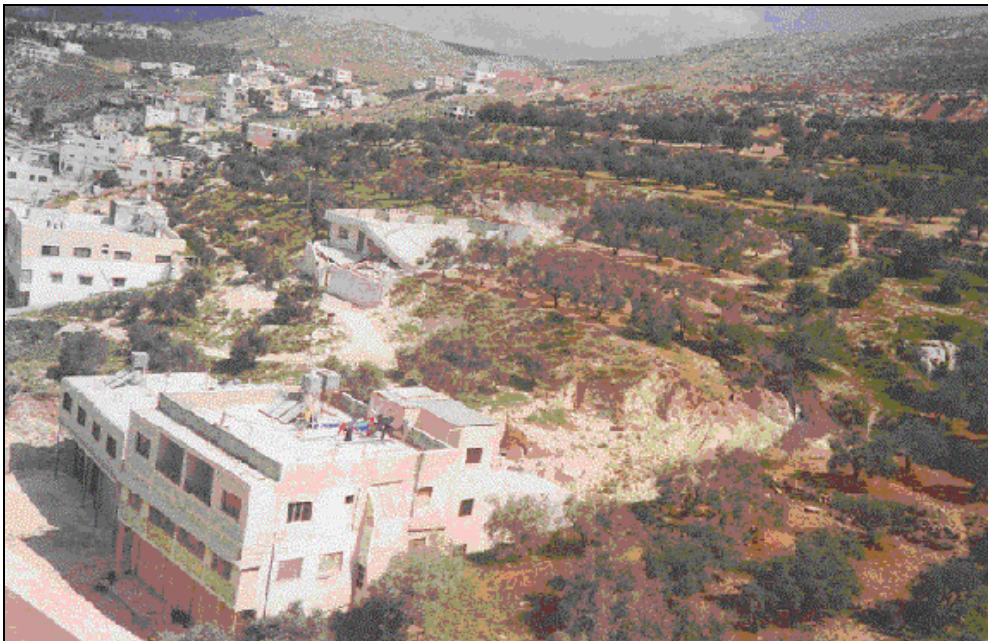
- A house subjected to sliding and thus moving horizontally causing the house completely failure, as shown in Figure 3.
- The main street between Nablus and Tulkarm at the bottom of the landslide area subjected to uplift and horizontal forces and that led to uplift and horizontal movements, as shown in the bottom of Figure 4.

Figure (3): A Photograph shows the Landslides and the damaged house in

the White Mountain

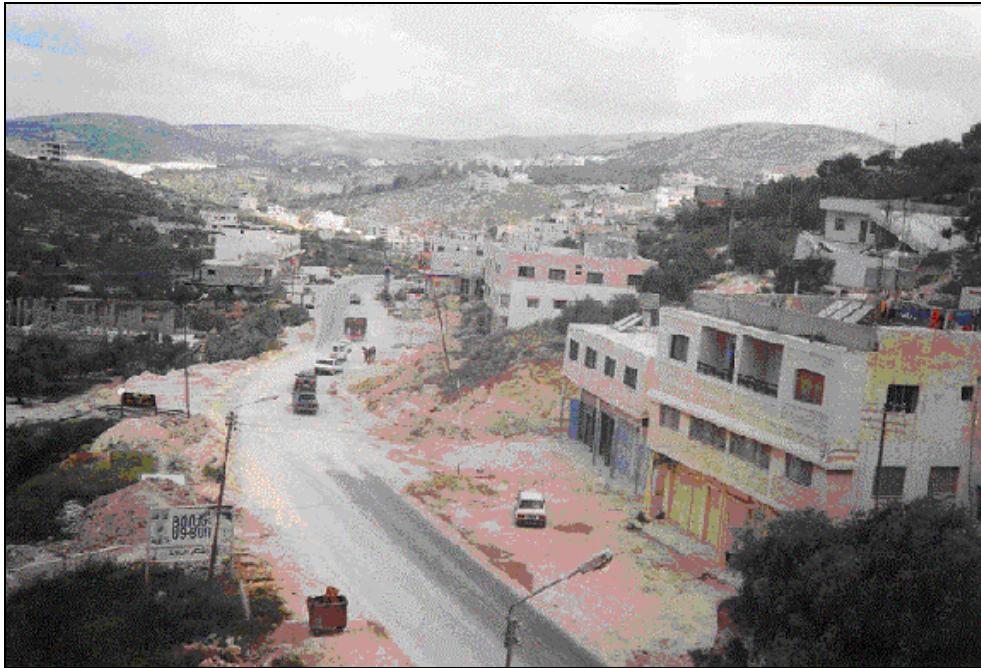
Figure (4): A Photograph shows the bottom of Landslides and Nablus – Tulkarm damaged main street in the White Mountain

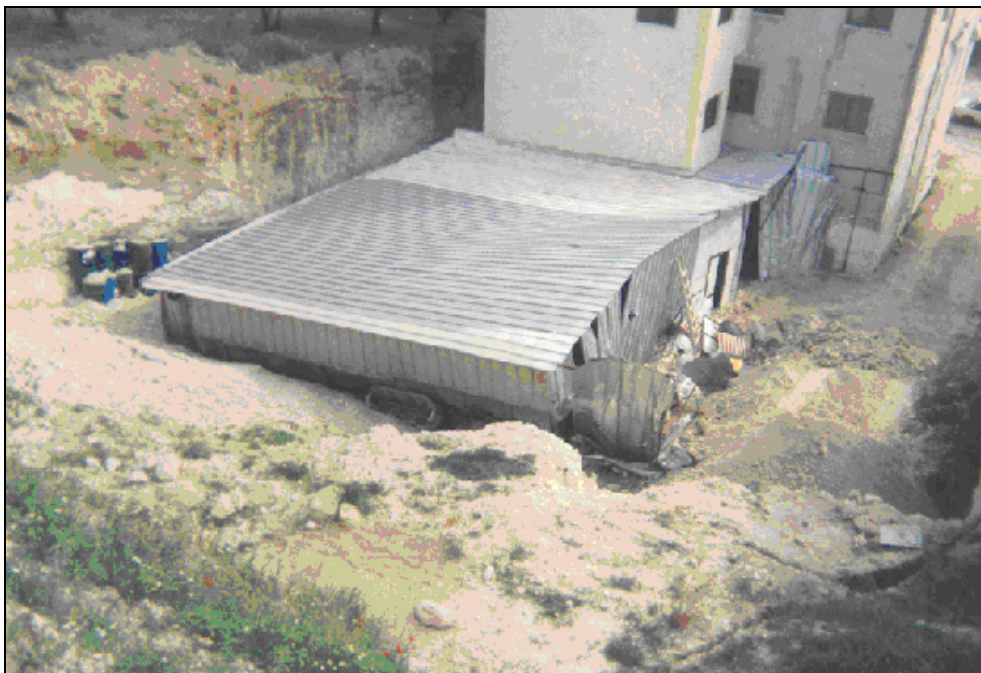
- Collapse of a barracks of steel structures in the landslide area. This structure subjected to horizontal movement, as shown in Figure 5.
- Another building at the bottom of the landslide subjected to horizontal and uplift movements. This caused cracks in the walls of the building and uplift movements in the ground floor.

Figure (5): A Photograph shows the damaged Barracks in the White Mountain

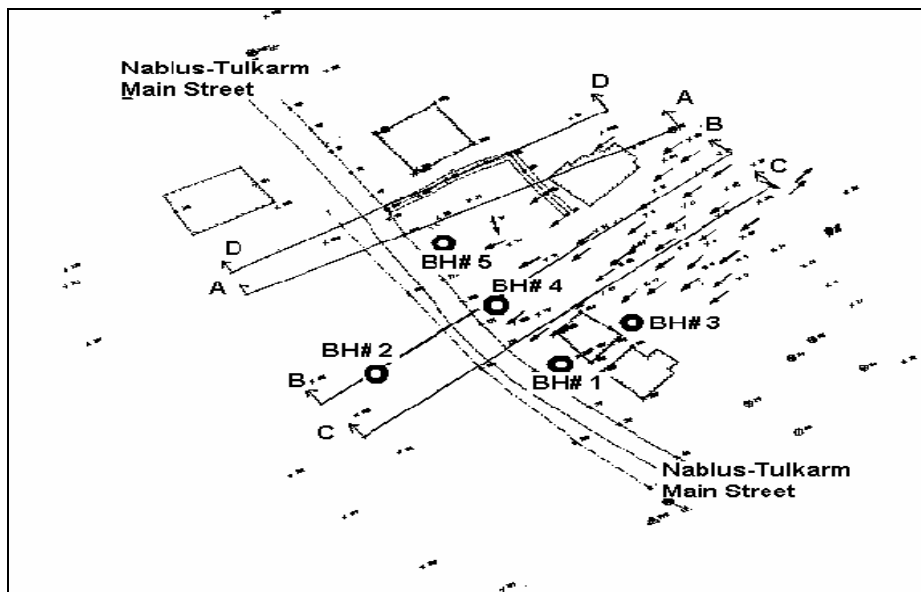
Figure (6): Location of the boreholes and cross-sections for slope stability

analysis

Slope stability analysis was done for several cross-sections across the site (sections A, B, C, and D as shown in Figure 6). The aim of this analysis is to locate the critical rupture surface (surface of minimum factor of safety). This analysis was done using numerical integration by a computer program called PCTANI (Hector, 1983). PCTANI is an interactive program that computes the factor of safety of slopes using Bishop's Modified Method. The program accepts data from a FILE as well as from the KEYBOARD. Data must be entered in the following order describing the slope geometry, soil properties, type of units used, soil data, and piezometric data. The program, also finds the coordinates of center and radius of the circle that have the least factor of safety.

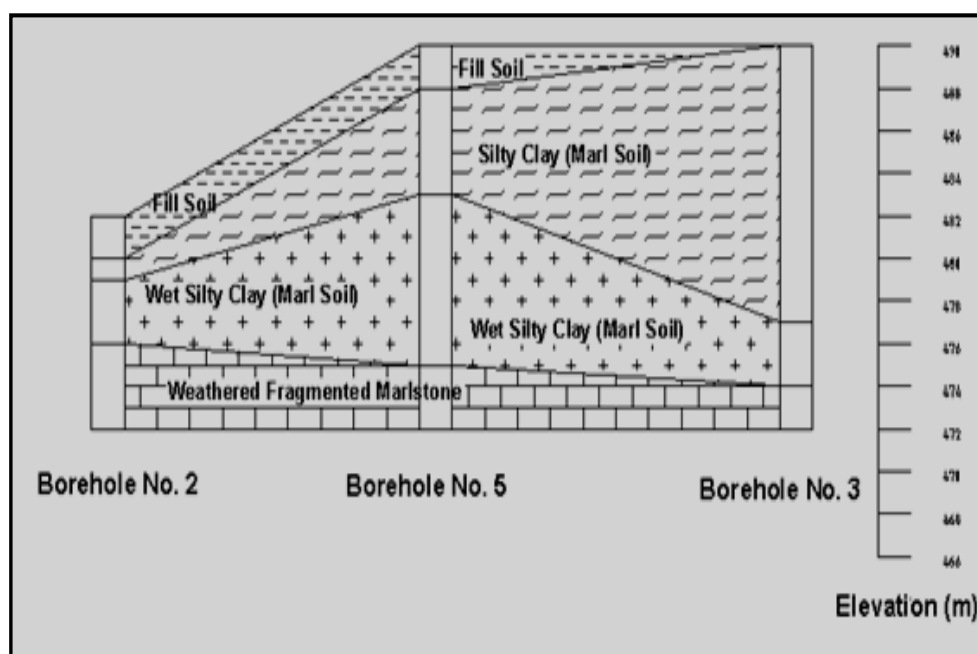
From borehole logs, geological sections (typical geological section is shown in Figure 7), and excavation in the site, the top soil of the site may be described as fill material which is mainly dumped soil from various sources, the depth of this layer ranges between 0.5 to 1.0 m. The soil below the fill material is white silty clay of low to medium plasticity (Marl Soil), mixed with aggregate of varying sizes, classified according to Unified Soil Classification System (USCS) as CL-ML. The thickness of this layer ranges from 8 to 16 m below the elevation of the main street. The soil below the marl soil is weathered fragmented and disintegrated marlstone of weak to medium strength.

Figure (7): Typical geological section in the sliding area

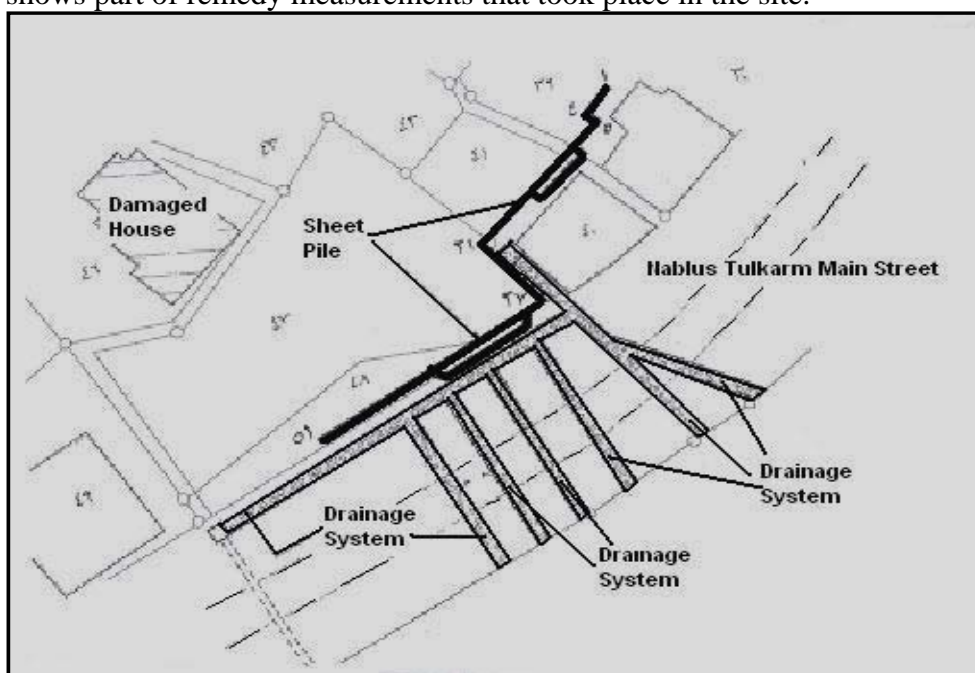
Figure (8): Part of remedy measurements that took place in the sliding site

Remedy measurements suggested to overcome the sliding problems in the White Mountain area are drainage of the rainfall water for both surface water and water that penetrated the soil layers, and installing an overall drainage system for the whole site including the top and bottom of the slope. Flattening the slope, recommended slope for this case is 1 vertical to 3 horizontal. Strengthening the bottom of the slope by introducing a row of bored cast in-situ reinforced concrete piles, to form reinforced concrete sheet pile. Planting the site with suitable type of trees to increase the strength of the soil and reducing soil moisture. Finally rehabilitation of the road in the lower part of the area using selected backfill materials.
